Study on Carbon Contamination to Prepare Titanium by Electrochemical Process

Tian Fu, Mengjun Hu* and Guoji Zhao

Citation: Tian Fu (2022) Study on Carbon Contamination to Prepare Titanium by Electrochemical Process. J Mater sci Appl 5: 1-9

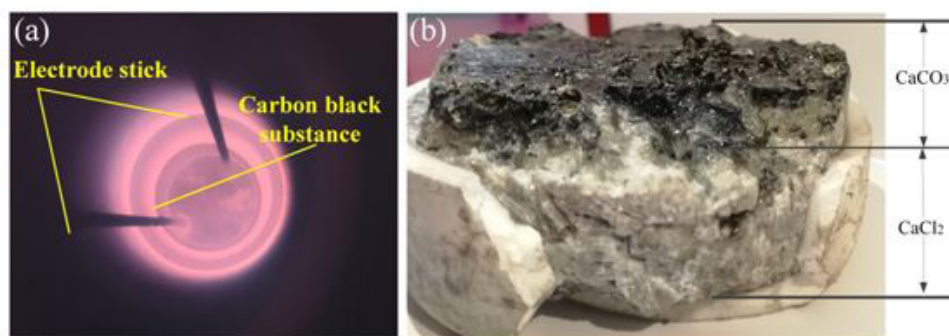
Figure 1: (a) Photo of molten salt surface; (b) Photo of molten salt after electrolysis

process of electrolyzing titanium oxide in CaCl_2 based molten salt to produce metal, a layer of carbon black substance is found on the surface of molten salt after electrolysis, as shown in Figure 1[21]. It is seen from the section of molten salt that about one third of molten salt is contaminated and black after electrolysis. After electrolysis, cooled the crucible and washed. Collected the undissolved black substance, XRD results show that the main substance is CaCO_3 , as shown in Figure 2. The main reason for the formation of CaCO_3 is that O^{2-} ions from the deoxidization of the cathode move to the vicinity of the graphite anode to form CO/CO_2 . CO_2 dissolved in CaCl_2 molten salt reacts with O^{2-} ions removed from the cathode to form CO_3^{2-} ions. Therefore, there is a large amount of CaCO_3 on the surface of the frozen salt. At the same time, CO_3^{2-} can be reduced on the cathode by electrons and amount of carbon produced. These carbon falls into molten salt and carbon layer floats on the surface of the molten salt can easily connect the cathode and anode caused short-circuiting and reducing the current efficiency of the process [22]. However, the size of carbon is very small caused it is difficult to collect during washing. That why it is not carbon phase in XRD patterns. It can be seen that CO_3^{2-} formed from O^{2-} and CO_2 and carbon produced in deoxygenation process have serious contamination to the molten salt and decrease the current efficiency of the whole process.

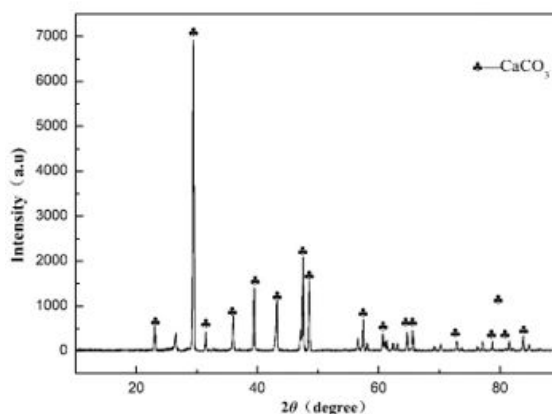
Figure 2: XRD patterns of the black salt

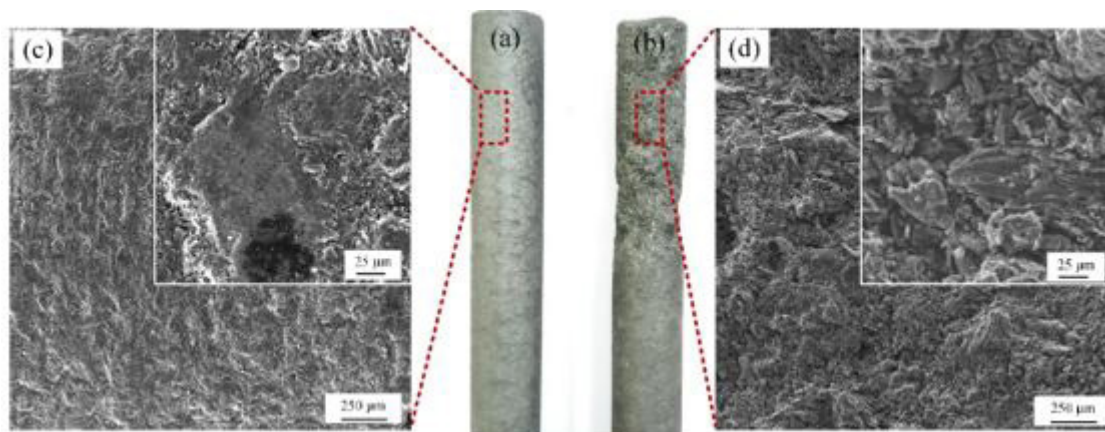
Figure 3: Photos of the graphite anode (a. before electrolysis, b. after electrolysis); SEM image of anode surface (c. before electrolysis, d. after electrolysis)

Figure 3 shows the appearance of the anode before and after electrolysis in molten CaCl_2 . It can be seen that the anode in molten salt is obviously consumed after the electrolysis, and the upper part is almost the same as before the electrolysis. Of course, the degree of anode consumption is closely related to the quality of cathode oxide, deoxidation time and deoxidation degree. Here, the anode morphology after electrolysis is given to explain the electrolysis process. Part of the anode emergence in

molten salt is consumed by CO and CO_2 produced on the anode. With the increase of the reaction time, the anode consumption increases, the anode diameter decreases obviously, the surface presents honeycomb shape and the surface are rough and uneven. It can be seen that the consumption of carbon anode immersed in molten salt is obvious increase with the electrolysis time. The anode structure is damaged and looks loose and porous due to the reaction erosion, as shown in Figure 3(c). Is there free carbon from the corroded part of the anode falling off and soaking into the molten salt?

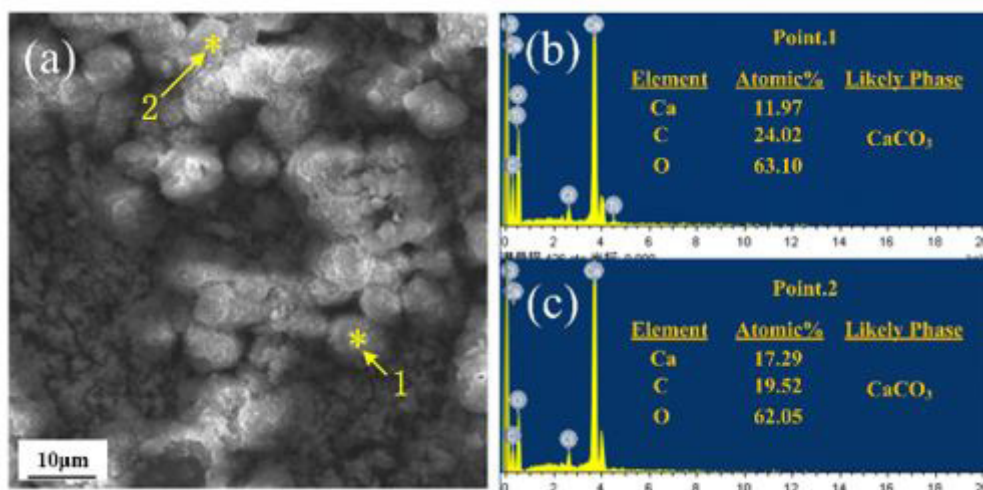
Figure 4: SEM-EDS results of the samples electrolyzed for 10 minutes (a SEM image of the sample surface morphology; b. EDS results of point 1; c. EDS results of point 2)

Figure 4 shows the morphology and elemental analysis of the sample electrolysis for 10 minutes. Figure 4a shows the appearance of the small particles on the surface of the sample, fur-

ther phase analysis of the sample also proved that CaCO_3 existed in the sample electrolyzed for a short time. Figure 5 is SEM mage of the surface scanning of the sample cross section electrolyzed for 60 min. It can be seen that the sample is obviously layered, the outer layer is dense, the middle layer is loose porous layer, and the inner layer is denser. The main phase of the outer layer is CaCO_3 .

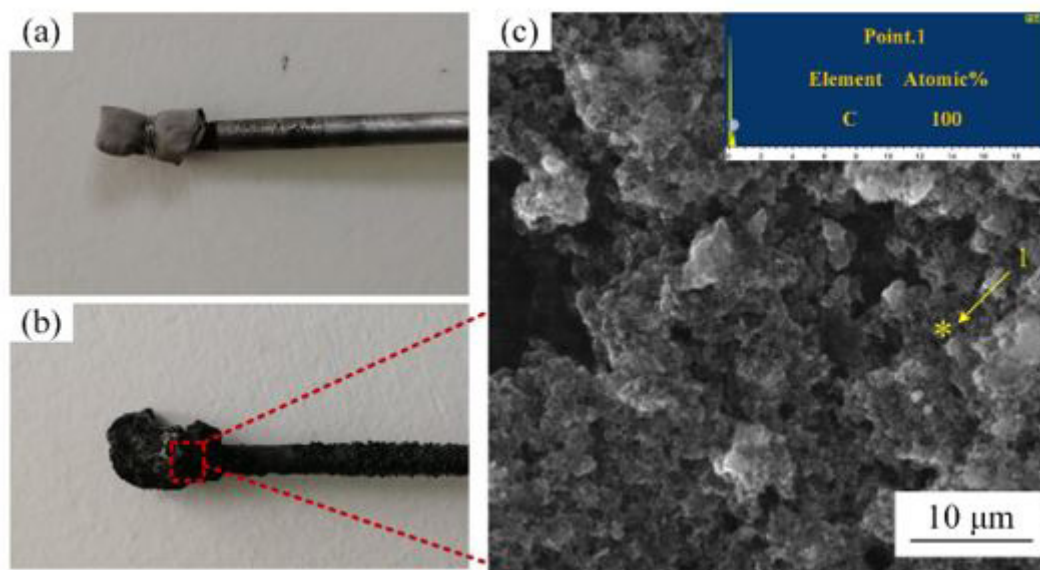
Figure 6: The photo of the cathode (a) before electrolysis; (b) after electrolysis ;(c) SEM image of the cathode surface substance

Before electrolysis, TiO_2 powder was wrapped with the mesh nickel screen and then tied to the cathode with molybdenum wire, as shown in Figure 6a. After electrolysis the cathode is lifted off the molten salt surface and cooled. It is found that the sample is wrapped by a lot of black material, as shown in Figure 6b. The black substance on the cathode surface was analyzed by SEM and XRD. It was found that the main phase is carbon.

The material enclosed in the outer layer of the cathode is unconsolidated and porous structure carbon, as shown in Figure 6(c), which is easily fall into molten salt. It was found that the cathode product was completely covered by carbon powder. Where does carbon on the cathode come from? It is found that O^{2-} can capture CO_2 to form CO_3^{2-} in molten salt. CO_3^{2-} can be reduced to C or CO at the controlled electrolysis voltage. There are lots of researches about utilization of carbon and reducing carbon dioxide emissions. It shows that carbon which is product of carbon evolution reaction of CO_3^{2-} wrapped on the cathode. In order to determine whether the product titanium was polluted by carbon, the samples were analyzed by XRD. The results showed that TiC phase appeared in the cathode product, as shown in Figure 7. The electrochemical reduction behavior of parallel side reactions in the cathode will affect the purity of metal products, which is

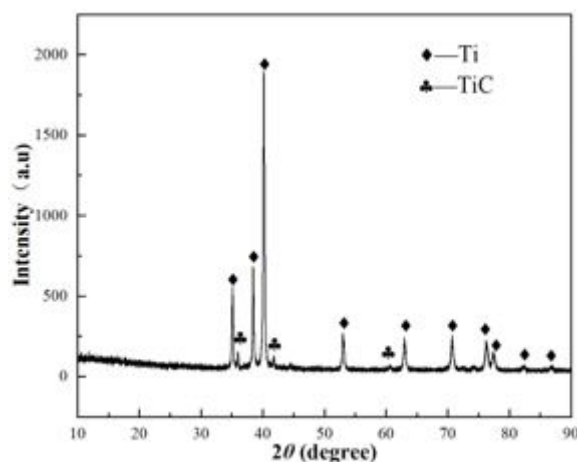
Figure 7: XRD patterns of the sample (a. XRD patterns of the product; b. XRD patterns of the cathode surface substance)

It can be seen that the final titanium product includes some TiC due to carbon evolution of CO_3^{2-} in the electrolysis process. The carbon evolution of carbonate is accompanied by the whole de-oxidation process of titanium oxides, which is the main cause of carbon pollution in the final product. Based on the study it can be known that CO_3^{2-} produced from the reaction of O^{2-} and CO_2 in the molten salt are the main reason caused contamination of the molten salt and the final product titanium. Hence, how to promote CO_2 releasing fast from the anode is the key way to decrease carbon continuation.
